# Lesser horseshoe bat mitigation on a major road scheme in South Wales

A465 Heads of the Valleys  
*Section 2: Gilwern - Brynmawr*

## A465 Heads of Valleys Road (Section 2)

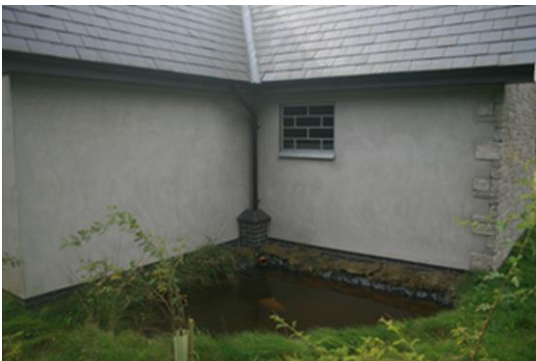
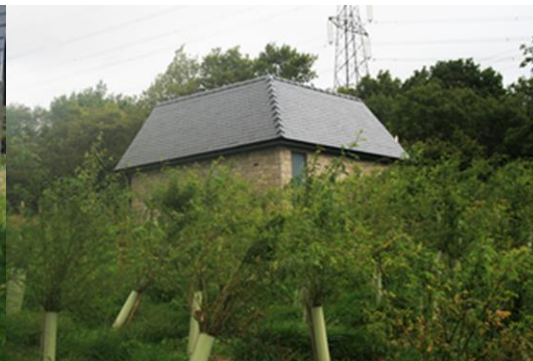
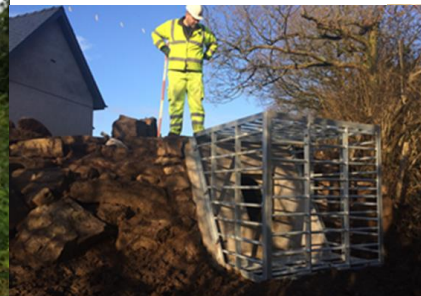
# Roosts – New Bat House

**Impacts** - Loss of 4 day and night roosts and 1 low-use hibernation site in an old mine adit

**Mitigation** - Provision of 5 new underground roosts, bat house, 4 'stepping-stone' roosts along Section 3 (compensatory measures) and improvements to Clydach House maternity roost

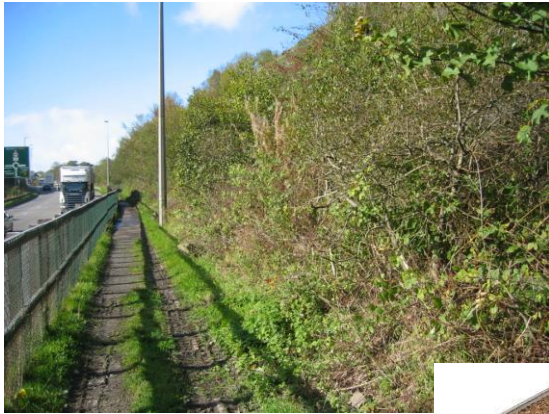
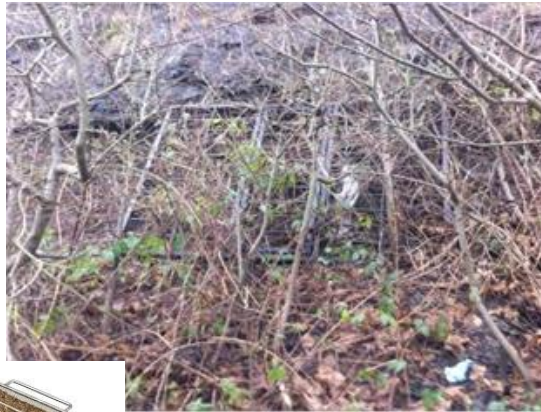
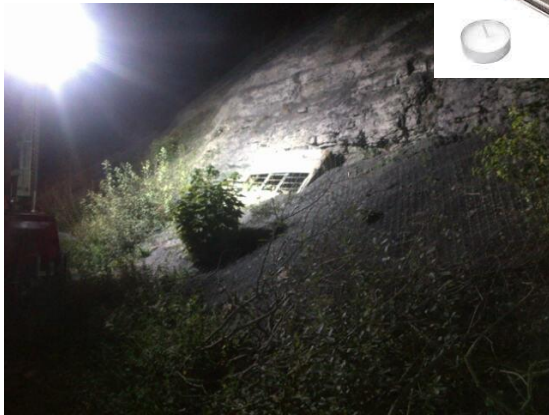
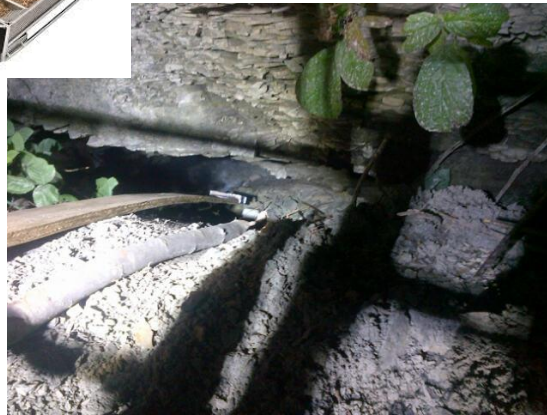
# Closure of Coal Tar Adit – minor hibernation roost

- Monitored using static bat detector
- Vegetation clearance, floodlighting and partial obscuring of entrance did not deter bats
- Sawdust food smoker lit 1 hour after sunset to allow bats to exit – burned for 16 hours, beyond dawn
- No bats recorded after second night of using smoker, so adit closed
- Continued to monitor bat activity inside adit for 3 nights to check if any trapped inside

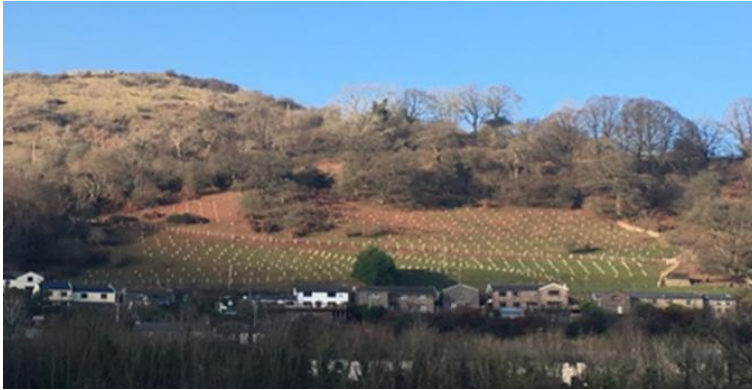
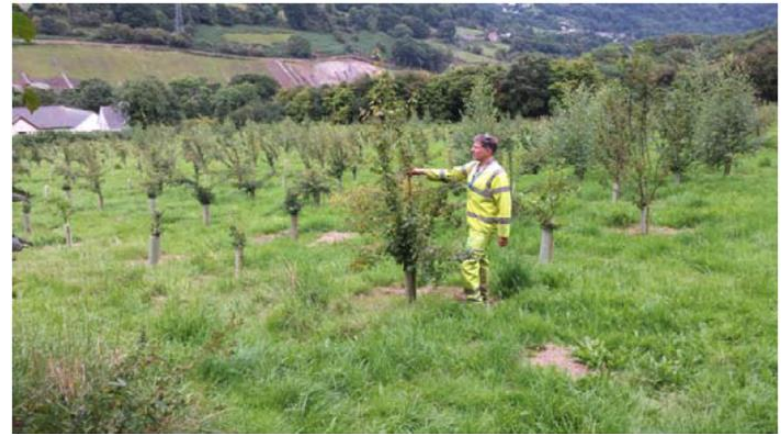
# Woodland foraging habitat

**Impacts** – Approx. 21 ha of woodland cleared - 18.42 ha within 1 km of maternity roosts and 1.2 km of hibernation roosts

**Mitigation** - Planting of approx. 23 ha deciduous woodland. Replacement ratio at least 1:1 within SAC and roost zones

BMA M – over 2 years growth, 2014/15 season

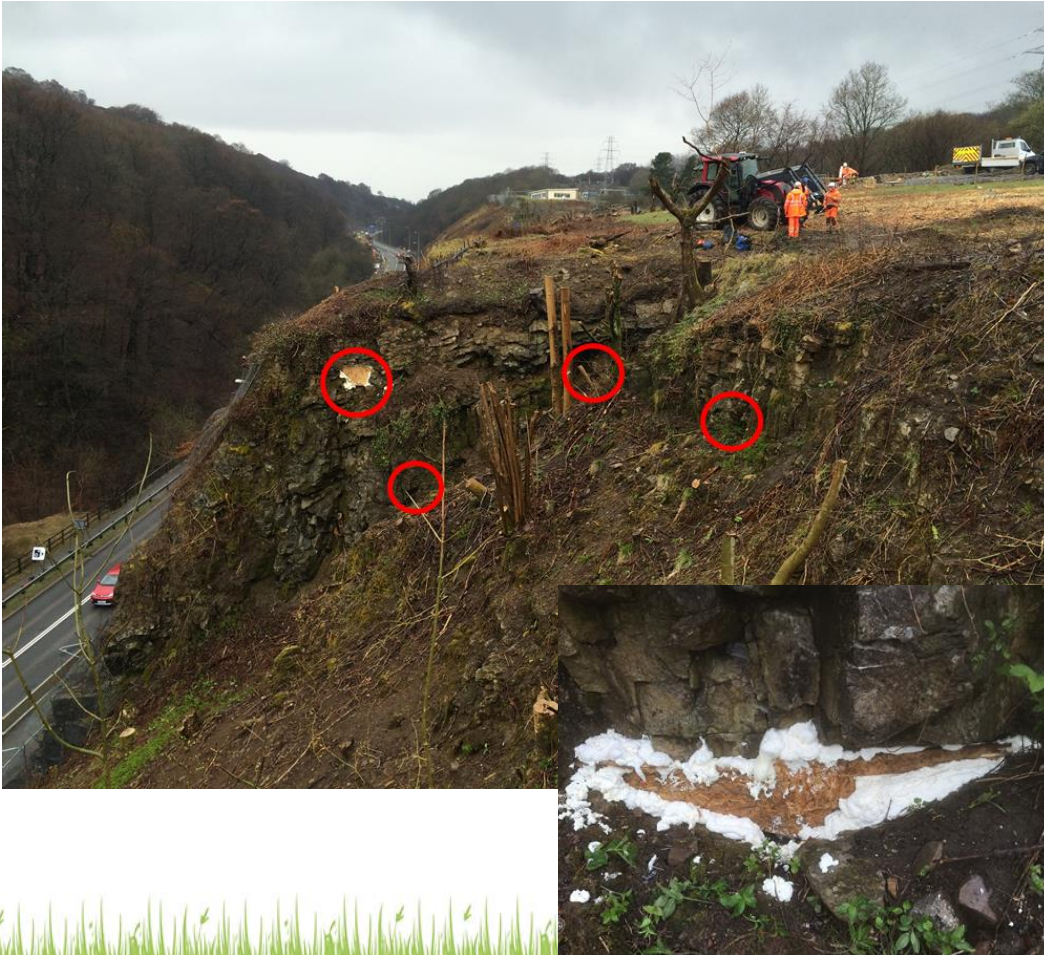
# Disturbance

**Impacts** - Disturbance of bats in Clydach Viaduct maternity roost and caves under the road

**Mitigation** - Timing and sensitive working practices – Karst Protocol/method statement

- 4 small caves/overhangs in cliff to be excavated
- Rope access work
- Road closure needed to work at caves because of rockfall risk
- Not feasible to use 'smoker'
- Entrances boarded over in May 2016 with 30 mm high opening at the bottom to allow bats to crawl out and discourage return
- Ecological watching brief during excavation – no bats seen

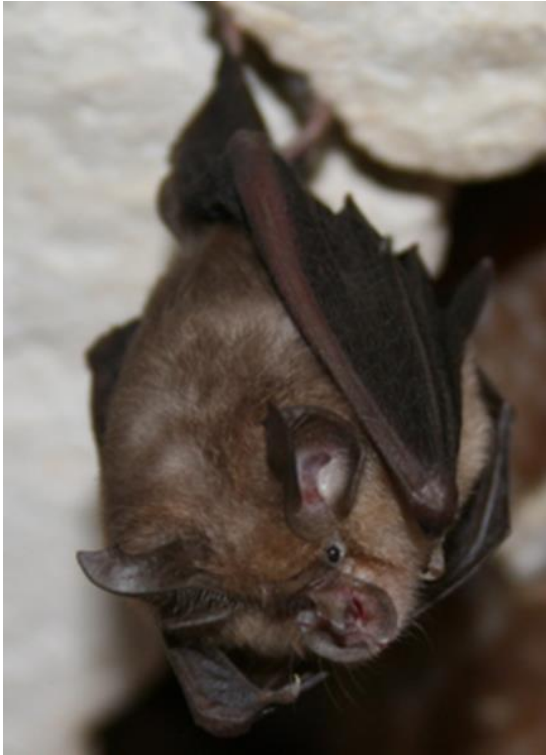
# Monitoring

- Monitoring undertaken annually during construction, for five years after 'opening' and years 7 & 10, i.e., 2015 - 2029
- New roosts monitored by internal inspection four times annually (spring, summer, autumn, winter)
- Continue pre-parturition and juvenile counts at maternity roosts
- Continue hibernation counts of caves
- Monitoring schedule includes a sample of 5 under-road crossings formally monitored (out of 11 affected), manually and using static detectors, plus additional ad hoc monitoring of others
- Monitoring at Hopyard Underpass (Section 1) 2014 - 2017

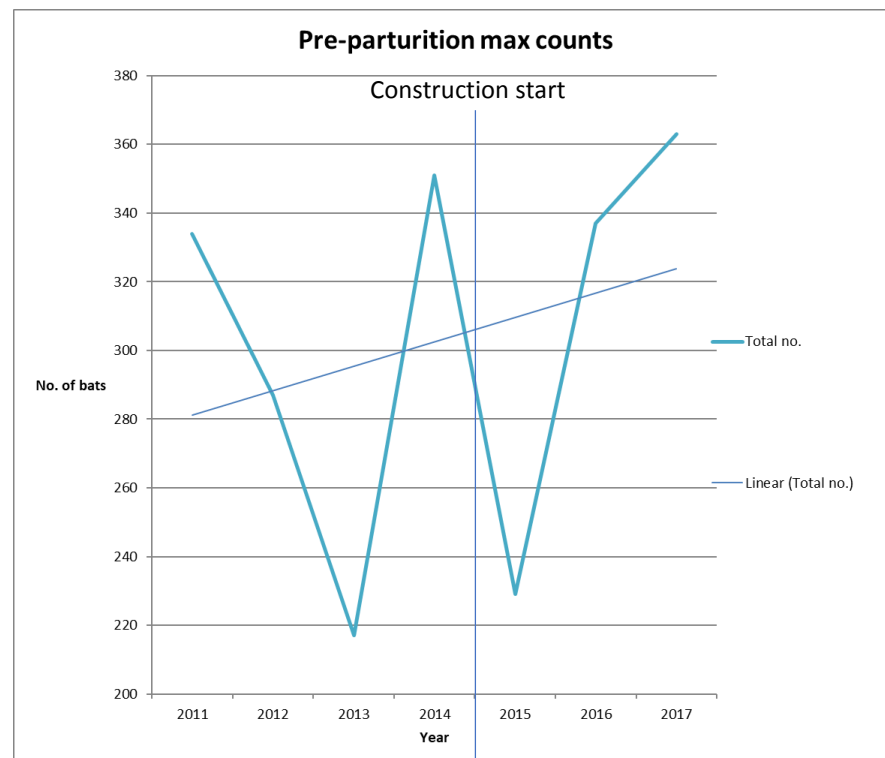
# Pre-parturition counts

- 2 counts late May/early June (NBMP method)
- Initial dip in 2015 but then increased. May 2015 was cold and births a week later than normal. July adult counts compared favourably to previous years.
- Summer 2012 was the wettest for 100 years and may have affected numbers in 2013
- 5-year trend is positive
- Increase in numbers at Clydach House may be due to installation of hot-box and enlarged access

Pre-parturition max counts	2011	2012	2013	2014	2015	2016	2017
Auckland House	94	99	84	148	64	93	115
Clydach House	59	57	45	77	89	114	102
Clydach Viaduct	39	40	13	35	6	77	59
Llanwenarth House	142	91	75	91	70	53	87
Total no.	334	287	217	351	229	337	363

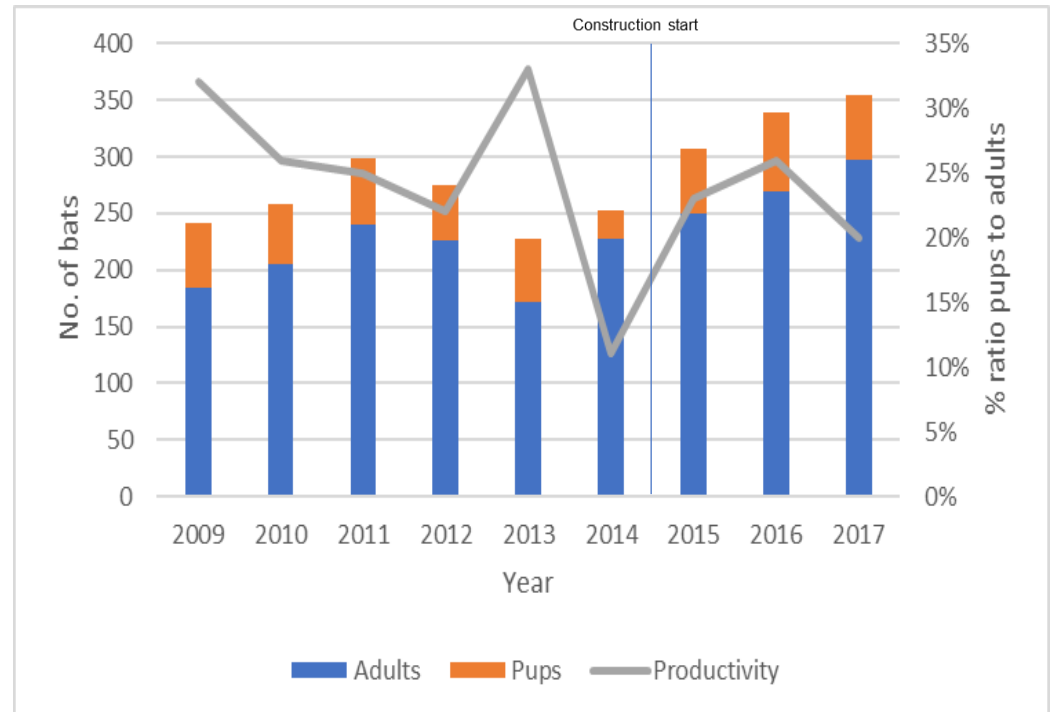
# Juvenile counts and productivity

- July emergence, followed by internal inspection to count pups
- Highest total pup count in 2016
- Adjusting figures to account for Welsh national trend of 3.2% increase from 1999-2015 (BCT), there has been no significant change in pup numbers since construction began
- Productivity fluctuations are within the range one might expect and give no cause for concern
- Bat house completed October 2015 – evidence of bat use in July 2016 with a mother and pup present. 2-3 bats regularly present

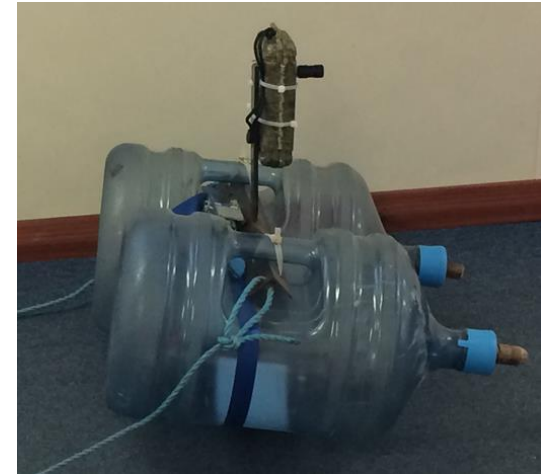
## Other river crossings and culverts

- Use of raft to mount detectors in culverts. Full spectrum vs zero crossing detectors where constant background water noise
- Bats recorded flying through 5/5 crossings monitored so far during construction (plus others). Max. baseline Bat Activity Index exceeded at least once at 3/5 crossings in 2016. 2017 data still to be analysed
- Insufficient baseline data to make statistical comparison, i.e., some crossings only monitored for one night during baseline data collection, but shows that road is permeable to bats

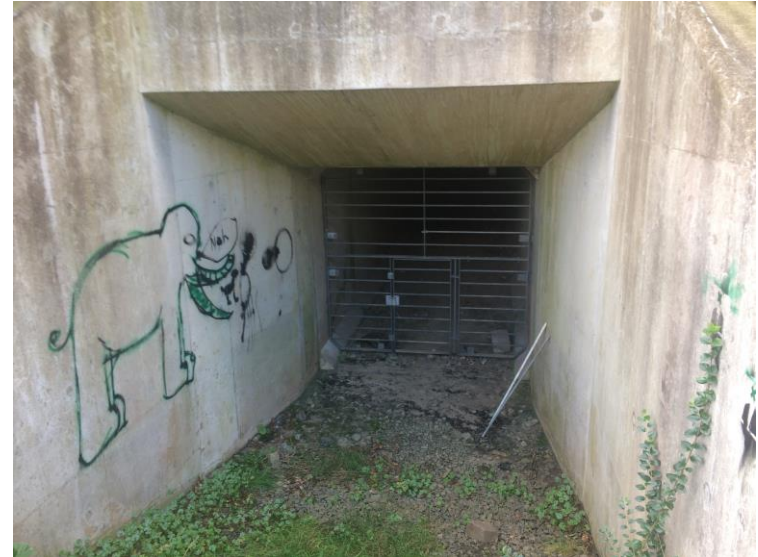
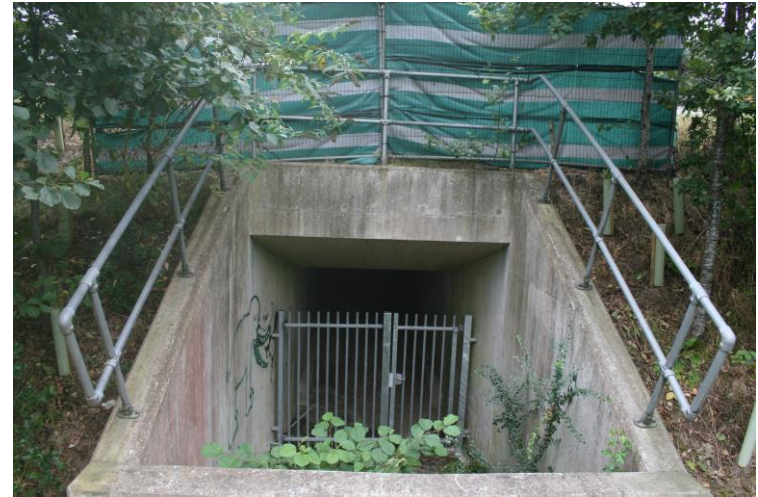
# Hopyard underpass (Section 1)

- Bat underpass at west end of Section 1 - constructed 2006; road opened 2008; monitoring until 2013. Monitoring concluded that bats were passing through the underpass without hindrance from the grilles.

- Section 2 works may have altered vegetation over northern portal so monitoring continued for baseline.
- Bats seen flying over the road in 2015 so monitoring adjusted to include seven static detectors, spaced 5m apart over road, along with observers at each portal for one whole night in May, July and September.

- Early 2016 - Trees at entrance reduced in height; additional planting to fill gaps in understorey; vegetation cut back from road edge and screens erected above entrances. 19-33% of bats flying over the road; 67-81% flying through underpass

- Early 2017 – Grilles at each entrance replaced with security fencing providing a larger gap for bats to fly through. 2-7% of bats flying over the road; 93-98% flying through underpass
