# **From Bargain Basement to Fine Vintage: A Case of Bats in the Wine Cellar**

Graham Morgan BSc MSc CEnv MCIEEM

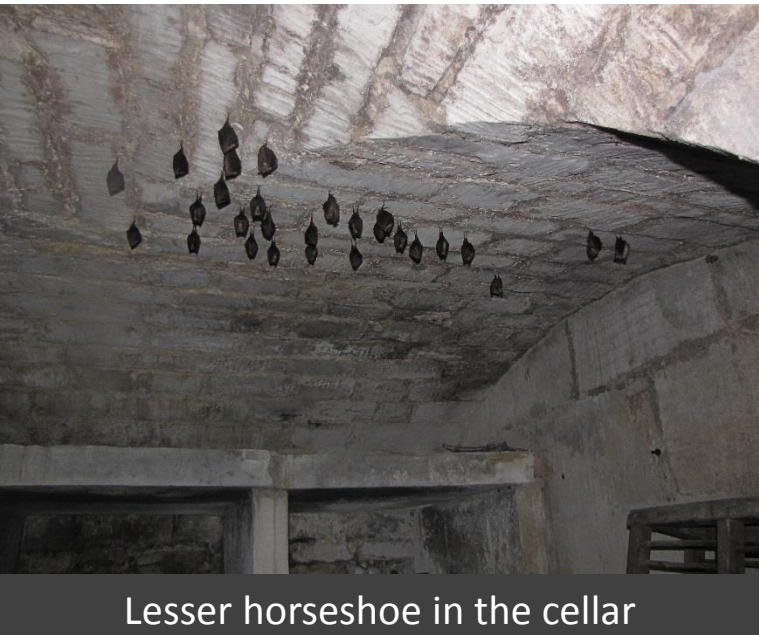
- Bats roosting in multiple locations throughout the large cellar with two access points

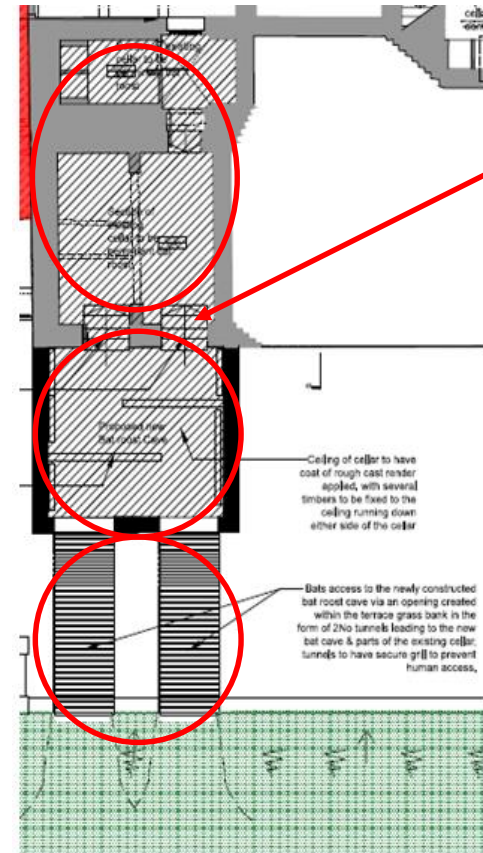
- Retained two existing rooms solely for bats (restricted locked access)
  - enhanced with rough timber partitions and box shelving
- Installed a 'bat cave' of concrete and block - a series of rooms with rough cast render, timber beams, with sealed joints and a damp-proof cap to control humidity.
- Created two new openings between the cave and the retained rooms
- Installed two concrete tunnels

**Bat cave = 2.2m (h) x 5.4m (l) x 5.85m (w)**

Retained sections of cellar

Bat cave

Access tunnels

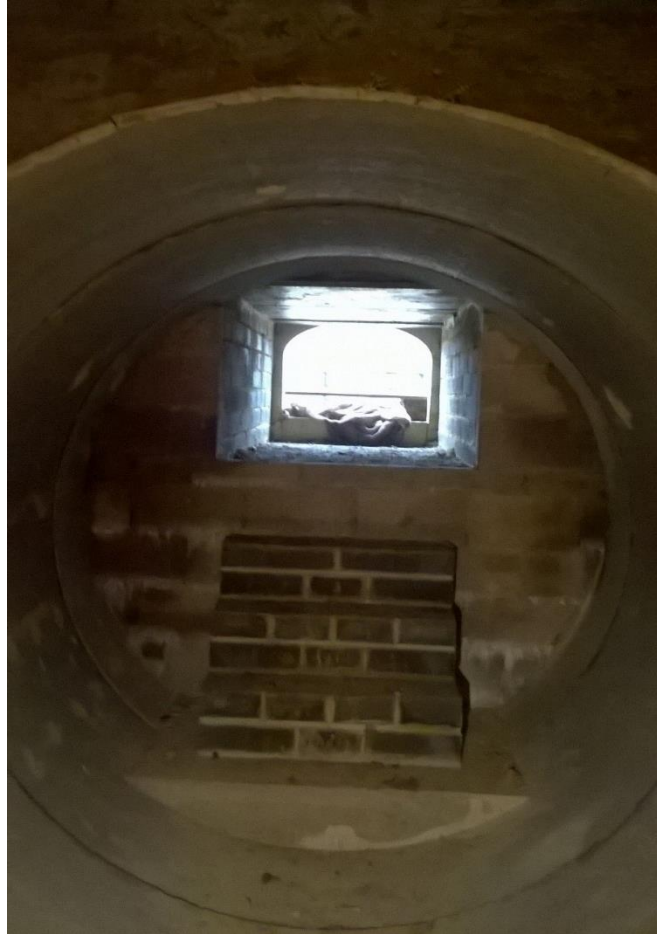
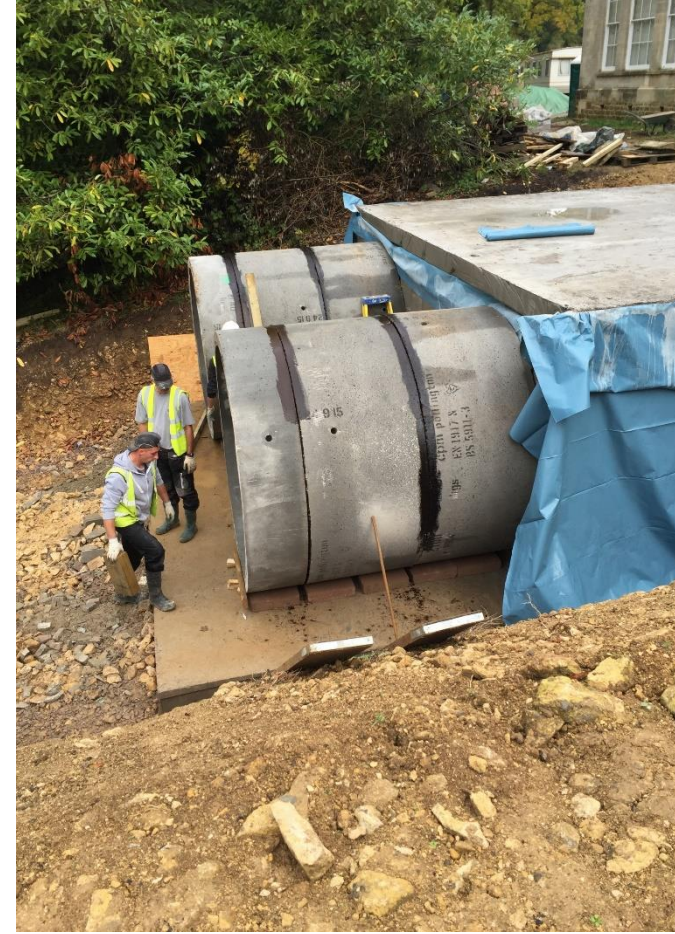
# Construction (3): Tunnels to the Bat Cave

- Tunnels 2m diameter
- Protected with 60cm x 60cm grilles with bar spacings 15cm high x 30cm long

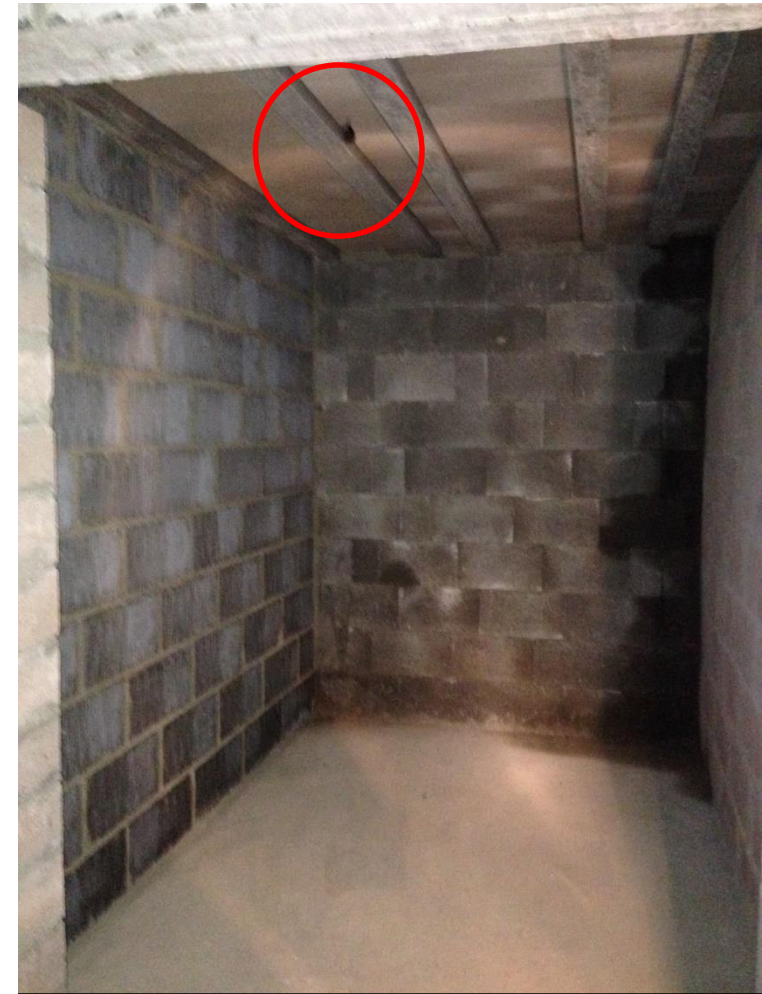
Lesser horseshoe in the new bat cave

- New/enhanced bat structures operational from early Nov 2015
- Monitoring also undertaken from Nov 2015 – Oct 2017 under licence
- Lesser horseshoe bats continued to use the cellar in low numbers from Nov 2015
- Bat cave first used by lesser horseshoe in June 2016
- Oct 2017 lesser horseshoe numbers up on previous post-mitigation levels

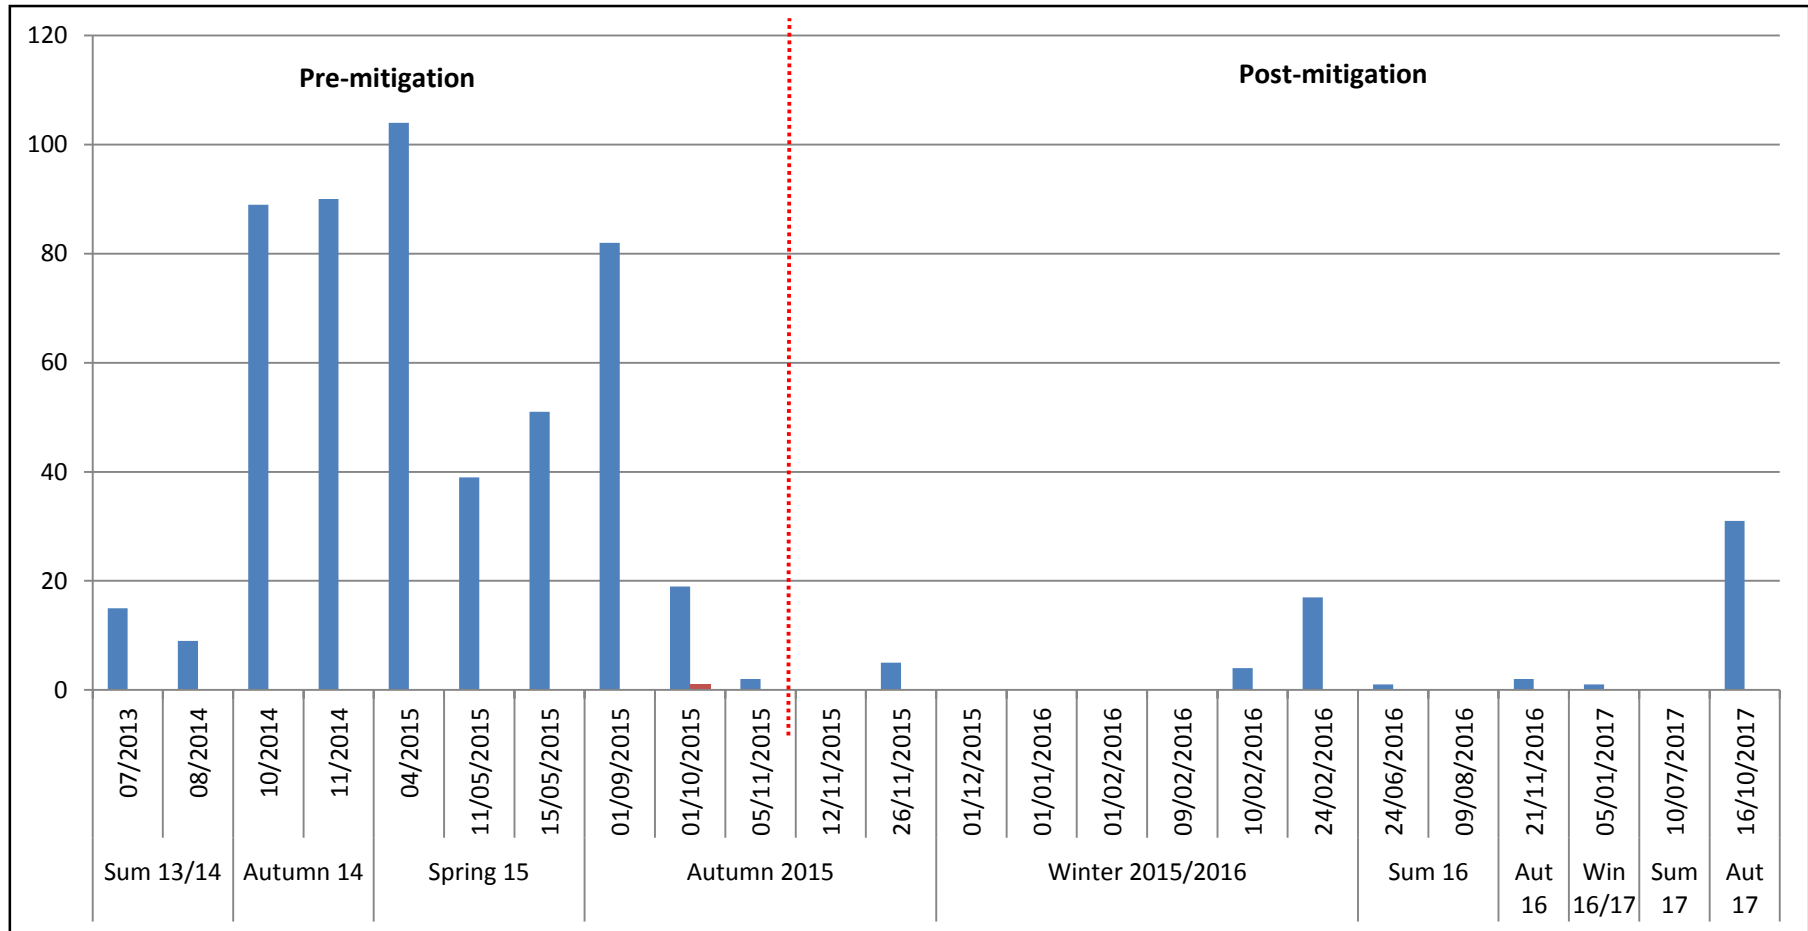
- Lesser horseshoe numbers in the overall cellar pre- and post-mitigation
