Beavers in the Greathough Brook, Forest of Dean, Gloucestershire

A nature based solution?

Forestry Commission England

October 16th 2018

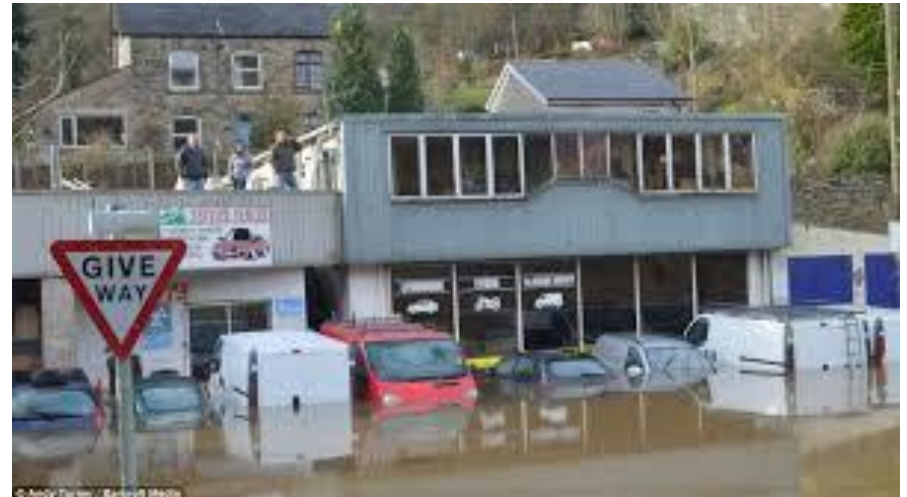
Greathough Brook has been identified as a key source of flooding

Feasibility study to evaluate the opportunity to reduce flow entering the culvert system by holding water upstream

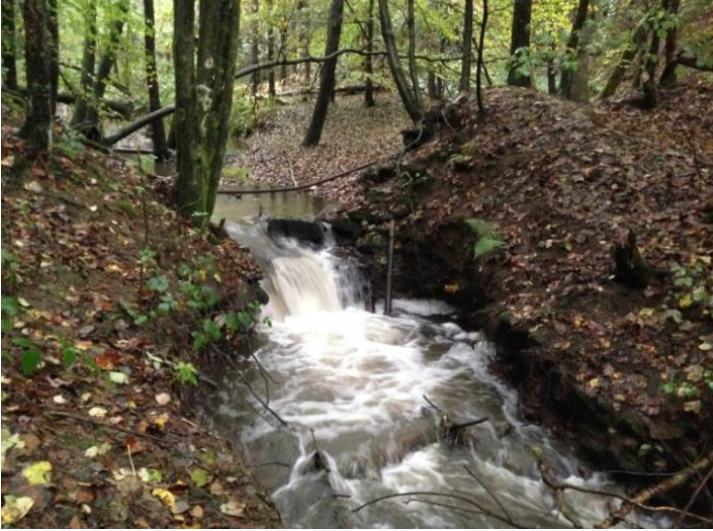
- Culverts are often narrower than the watercourse and in a poor state of repair
- They are often blocked with debris and difficult to monitor
- 1 in 30, 1 in 50 and 1 in 100 year events all generate flows greater than 3.8m³/s capacity

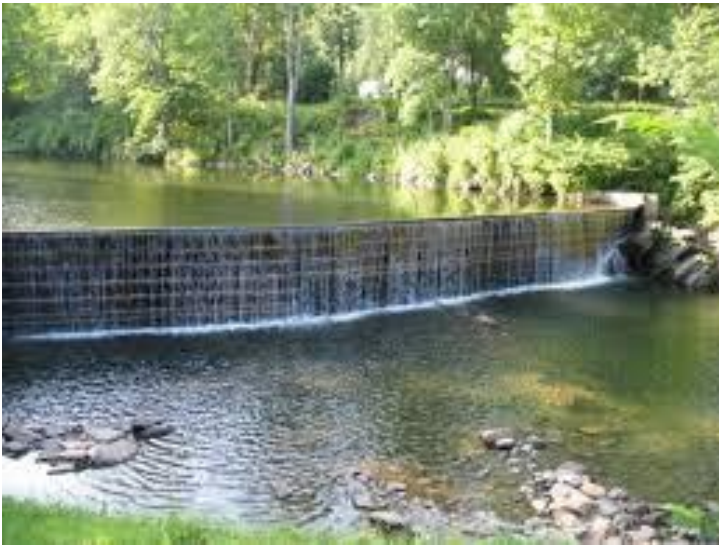
- Hard engineering
- 1 in 100 year flood attenuation not economically feasible

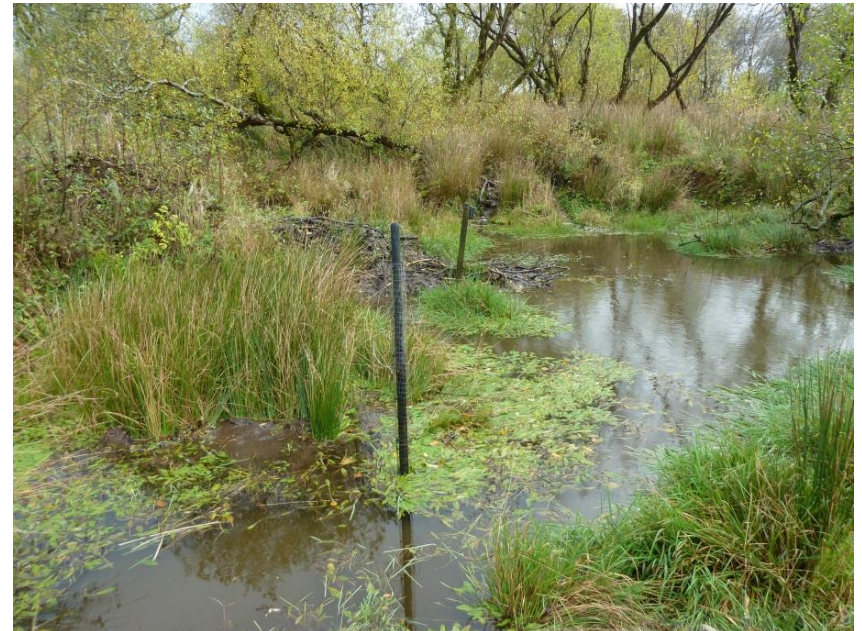
- Between 2011 and 2015, 14 major dam systems were created
- Site changed from a narrow stream to a complex braided wetland
